OFFICIAL INSPECTION FORM – NOT FOR VOLUNTARY ASSESSMENTS SUBSURFACE SEWAGE DISPOSAL SYSTEM FORM

Property Address: 783 Bay Road, Amherst, MA

Date of Inspection: July 12, 13, 14, 2005

Company Name: R. F. Sheehan Associates Inc. Mailing Address: 146 Taylor Street, Granby, MA

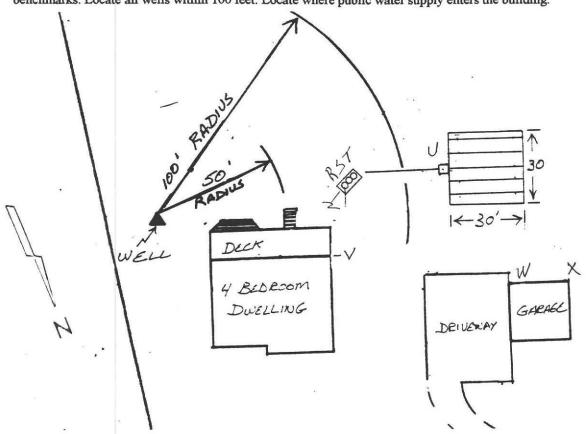
SKETCH OF SEWAGE DISPOSAL SYSTEM

TOP OF D-BOX 35" BELOW GRADE

V-R = 29.5 FEET, W-R = 80 FEET

V-S = 32 FEET, W-S = 77 FEET

V-T = 33.5 FEET, W-T = 75.5 FEET

W-U = 60 FEET, X-U = 75 FEET
