79 LARKSPUR Dr.

Title 5 Official Inspection Form

City/Town	State	Zip Code	Date of Inspection	
Amherst	MA	01002	07.16.2009	
Owner's Name				
Catherine Davies				
Property Address				
79 Larkspur Drive

A.	General Information		
1.	Inspector:		
	Alan E. Weiss, R. S., M. S.		
	Name of Inspector		
	Cold Spring Environmental Consultants Inc.		
	Company Name		
	350 Old Enfield Road		
	Company Address		
	Belchertown	MA	01007
	City/Town	State	Zip Code
	413.323.5957	Registered San	itarian #933

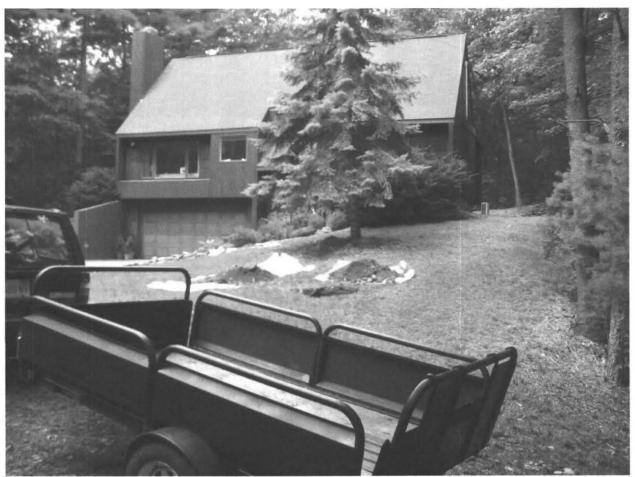
Septic Location 79 Larkspur Drive Amherst, MA 07.16.2009

Comments (note condition of pump chamber, condition of pumps and appurtenances, etc.): Soil Absorption System (SAS) (locate on site plan, excavation not required): If SAS not located, explain why: 2 lines noted out of D. box (size: 2' w. x x 50' l.+/- trenches) Type: leaching pits number: leaching chambers number: leaching galleries number: leaching trenches number, length: 2 @ 2' x 50' leaching fields number; number: leaching fields number; number: toverflow cesspool number: innovative/alternative system Type/name of technology: Comments (note condition of soil, signs of hydraulic failure, level of ponding, damp soil, condition of vegetation, etc.): No evidence of hydraulic failure, soil at top good no stone staining. (No standing liquid in stone).	/Town		-		TOTAL STATE OF CORPORATIONS	() A ()
Comments (note condition of pump chamber, condition of pumps and appurtenances, etc.): Soil Absorption System (SAS) (locate on site plan, excavation not required): If SAS not located, explain why: 2 lines noted out of D. box (size: 2' w. x x 50' l.+/- trenches) Type: leaching pits number: leaching chambers number: leaching galleries number: leaching trenches number, length: 2 @ 2' x 50' leaching fields number; number: leaching fields number; number: toverflow cesspool number: innovative/alternative system Type/name of technology: Comments (note condition of soil, signs of hydraulic failure, level of ponding, damp soil, condition of vegetation, etc.): No evidence of hydraulic failure, soil at top good no stone staining. (No standing liquid in stone).

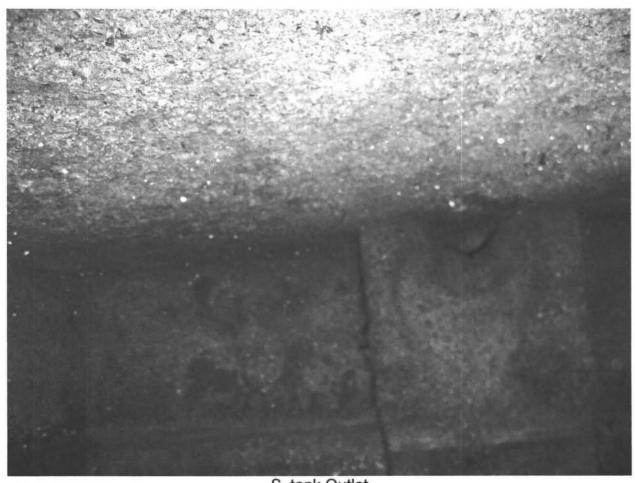
S. tank Outlet 79 Larkspur Drive Amherst, MA 07.16.2009

A)	System Passes:									
		in 310	not found any information wh CMR 15.303 or in 310 CMR ted below.							
	Co	mment	S:							
	All levels were good at inspection, system is reported repaired 11+/- years old. Tank pumped, (D. box, & S. tank had good levels and no indication of past high staining or ponding. Tank had tees was pumped. House used by 3 persons. Grinder is not recommended & should be removed.									
			2

8.5'X4.5'X4.'	
	Dimensions:				4"	
	Sludge depth:				38"	
	Distance from top of	of sludge to bottom	of outlet tee or b	affle		
	Scum thickness				4"	
	Distance from top of	of scum to top of ou	tlet tee or baffle		6"	
	Distance from botto	om of scum to botto	m of outlet tee o	r baffle	10"	9
	How were dimension	ons determined?			Measured

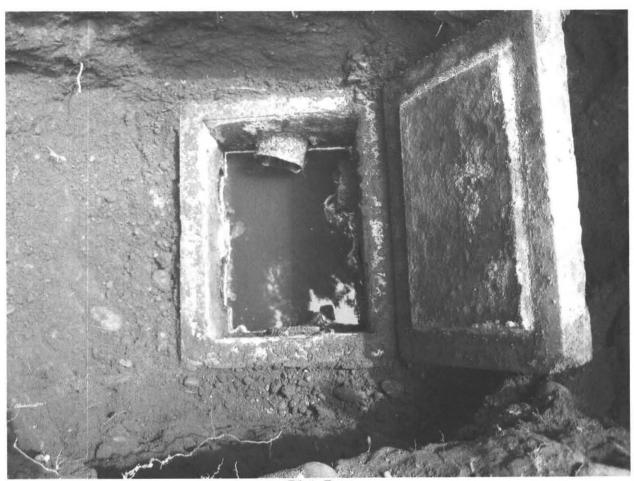
Dist. Box 79 Larkspur Drive Amherst, MA 07.16.2009

* Attach copy of current pumping cont Distribution Box (if present must be	opened) (loca	te on site plan)		Yes Yn	□ No
Depth of liquid level above outlet inver	t	<u>@ 1117. 10701</u>	9000. 20 . 001		
Comments (note if box is level and dis evidence of leakage into or out of box Good condition, level and good flow.		itlets equal, any	y evidence of s	olids car	ryover, any
Cod Condition, level and good now.					
Pump Chamber (locate on site plan):					
Pumps in working order:			☐ Yes	⊠ N	lo
Alarms in working order:			☐ Yes	\boxtimes N	lo
