### Title 5 Official Inspection Form

Subsurface Sewage Disposal System Form - Not for Voluntary Assessments

103 Larkspur dr.				
Property Address				
Thomas Smaldone				
Owner's Name				
Amherst	MA	01002	6/20/2013	
City/Town	State	Zip Code	Date of Inspection

## TITLE V REPORT

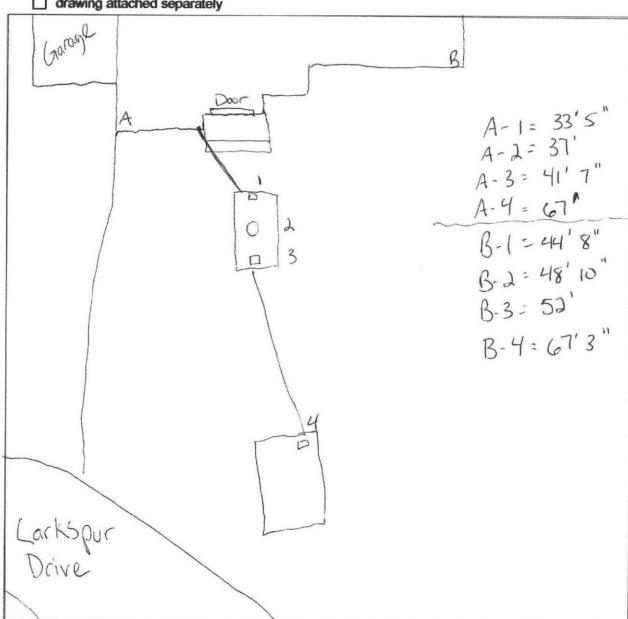
Sketch Of Sewage Disposal System: Provide a view of the sewage disposal system, including ties to at least two permanent reference landmarks or benchmarks. Locate all wells within 100 feet. Locate where public water supply enters the building. Check one of the boxes below:
