Subject: Title 5 Septic System Inspection at 14 Overlook Drive (Property of Prem Menon)

OFFICIAL INSPECTION FORM - NOT FOR VOLUNTARY ASSESSMENTS SUBSURFACE SEWAGE DISPOSAL SYSTEM INSPECTION FORM PART A

Property Address:	14 OVERLOOK DRIVE	
	AMHERS =	
Owner: PREM	MENON	
Date of Inspection:	6-25-03

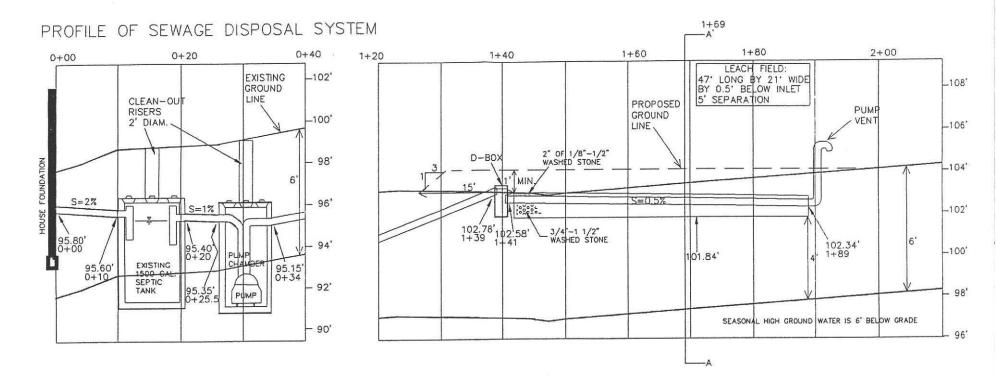
PROFILE OF SEWAG	E DISPOSAL SYSTEM
14 OVERLOOK D	RIVE, AMHERST,MA
BY: FILIOS ENTERPRISES, INC. 69 PELHAM RD. AMHERST NA 01002 (413)256-8008	FOR: PREMACHANDRAN & MIRA MEND 14 OVERLOOK DRIVE AMHERST, MA 01002
DRAWN BY: J.S.	SCALE: 1" = 3' VER.
OCTOBER 4, 1995	PAGE 2 OF 3

CALCULATIONS	
REQUIRED: For a 4 bedroom house without a g	orboge grinder
a copacity of 440.0 Gal./day X 1.25 = 550.0 Ga	l./day.
DESIGNED: 1 leach field 47.0'L X 21.0'W X 0.50	below inlet
(effective depth), for a perc rate of 15 min./in	, and a soil class of 2
yielding a loading factor of 0.56 gal./sq.ft. for	sidewall & bottom area
No side factor allowed.	= 0.0 Gal.
BOTTOM: (47.0' X 21.0')0.56 Gal./Sq.Ft.	= 552.7 Gol.
TOTAL	552.7 Gal.
