# TITLE V OFFICIAL INSPECTION FORM – NOT FOR VOLUNTARY ASSESSMENTS SUBSURFACE SEWAGE DISPOSAL SYSTEM FORM PART A CERTIFICATION

Property Address: 780 Bay Road

SEPTIC SYSTEM REPAIR PLAN FOR MICHELINE DAVIDSON 780 BAY ROAD

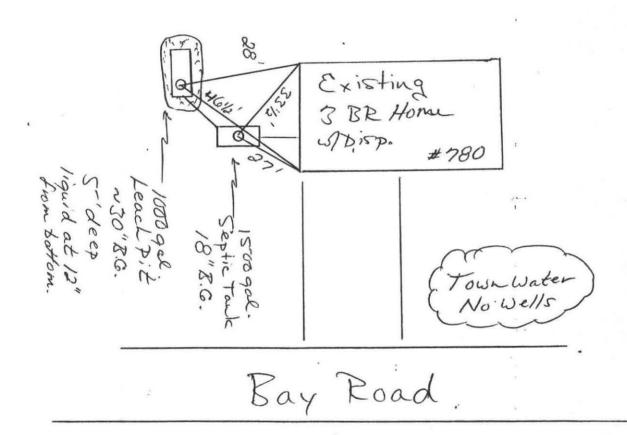
SKEICH OF SEWAGE DISPOSAL SYSTEM:
Include ties to at least two permanent references landmarks or benchmarks locate all wells within 100'

DEPTH TO GROUNDWATER	
Depth to groundwater: >/O feet method of determination or approximation:	Per original design. Almer Huntley + Assoc.
	Percand deep hales, April 16th 1995
	The state of the s
