# GIS and Flood Analyses of the Kromma Kill Watershed

Rami AlyGad, Adam Davis, Kelly Byrnes, Yu Shen, Katherine Meierdiercks  
Siena College, Department of Environmental Studies

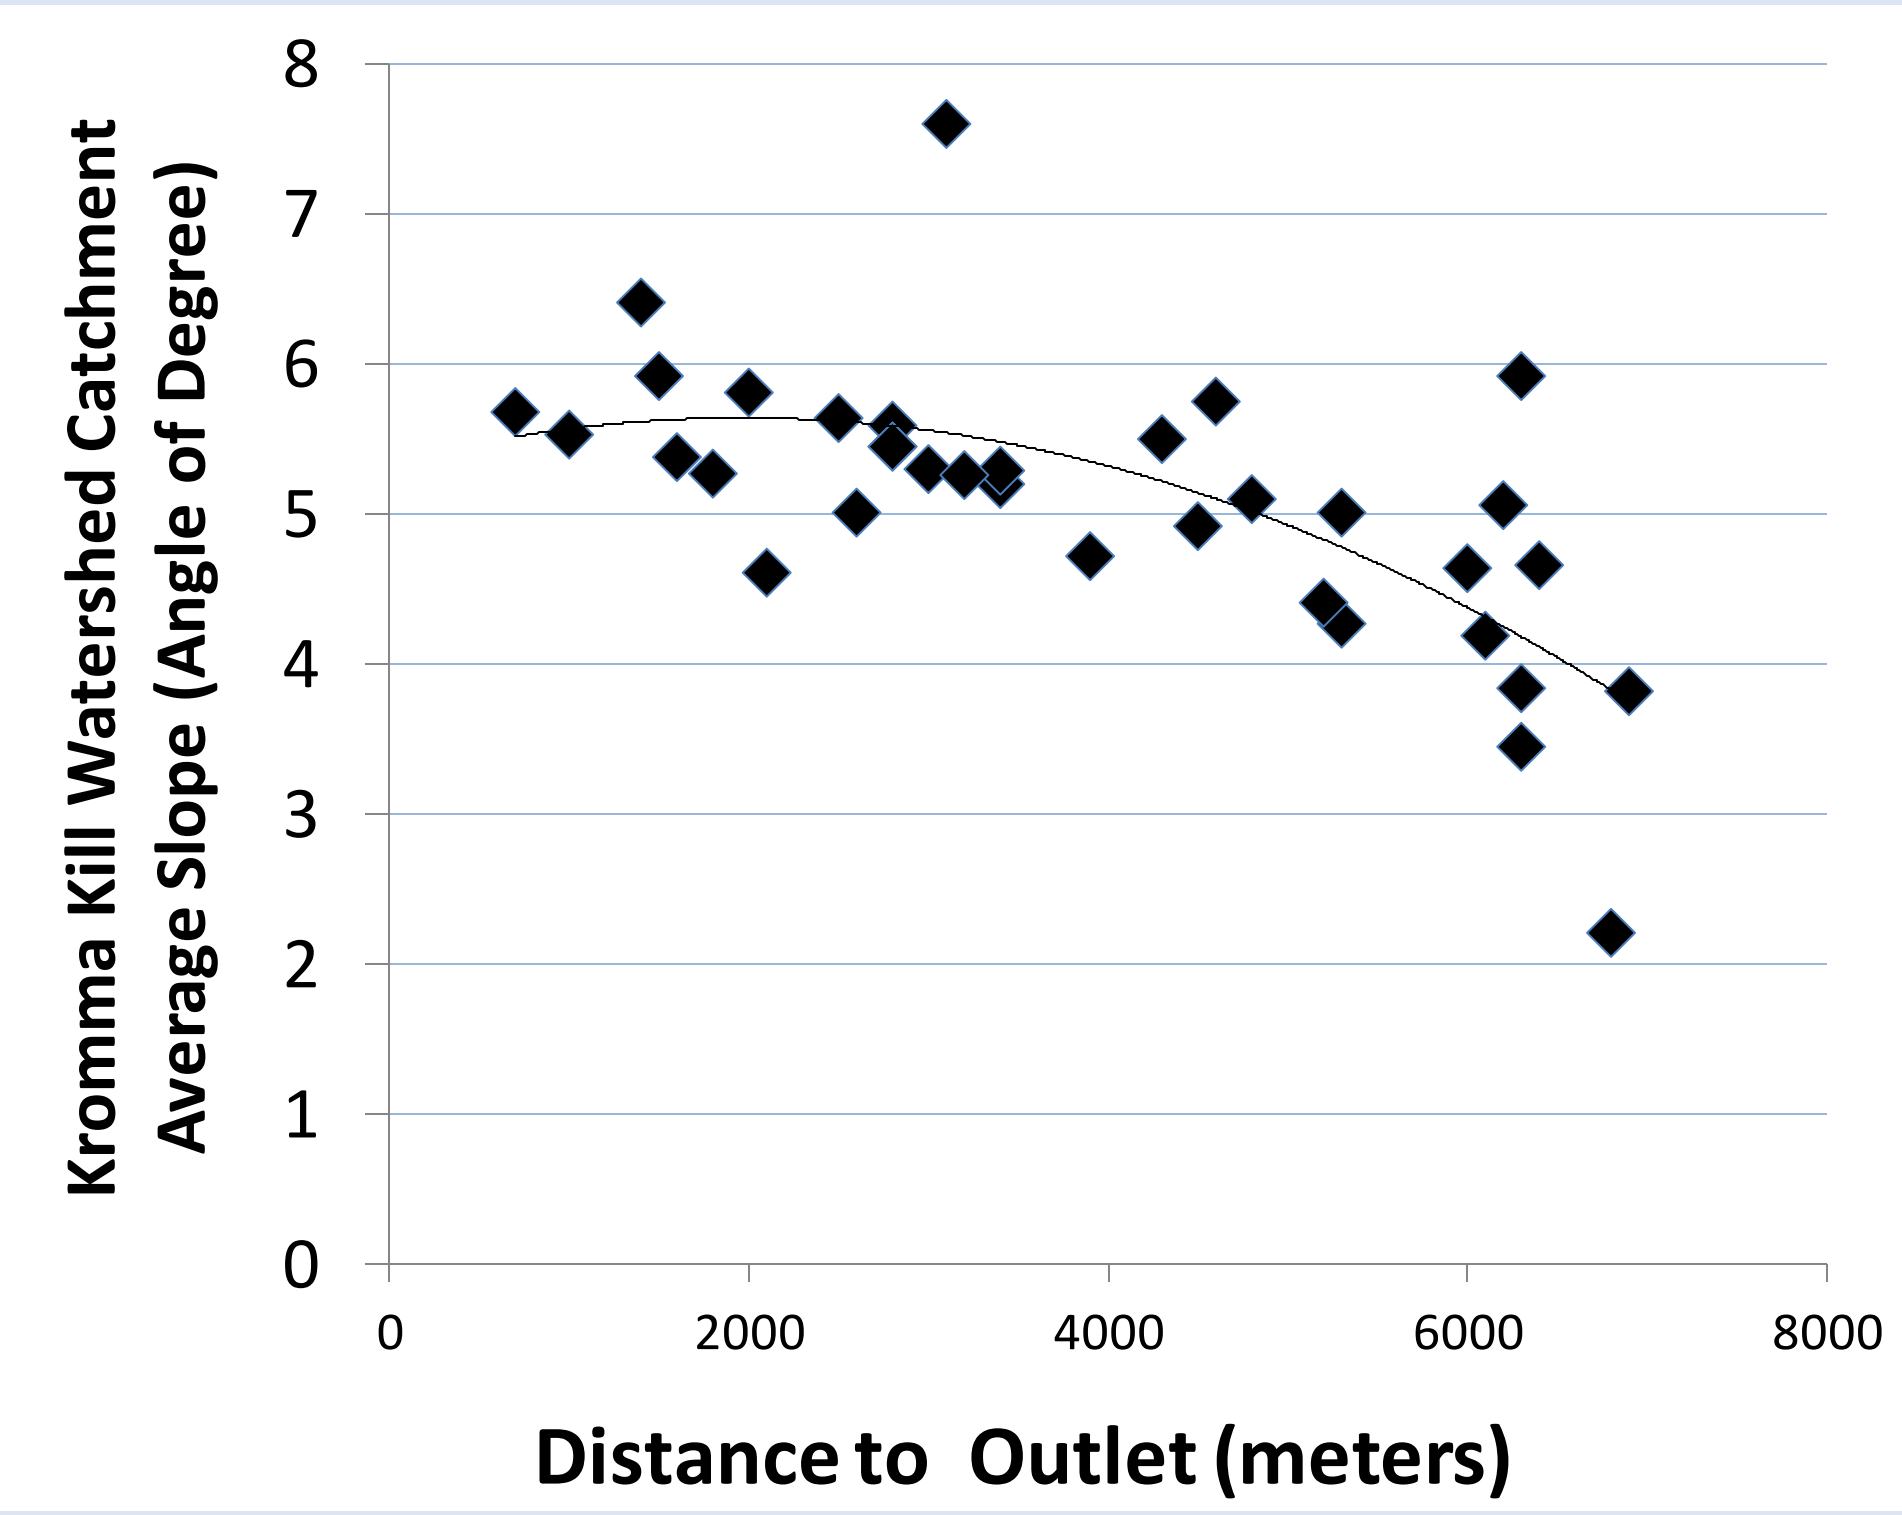
The above graph displays the analysis of average slope for the various subbasins located at different distances from the watershed outlet. Average slope has lower values at greater distances from the watershed outlet.

- The slope of the watershed decreases with increasing distance from the watershed outlet while the percent impervious increases with distance from the outlet.
- Width function analyses indicate that drainage density decreases with increasing distance to the outlet.
- Age of development varies throughout the watershed.
- Over the last century, alterations to the stream channel network include the straightening of channels and removal of holding ponds.
