200 Bay Rd.

SUBSURFACE SEWAGE DISPOSAL SYSTEM INSPECTION FORM
PART C
SYSTEM INFORMATION

SUBSURFACE SEWAGE DISPOSAL SYSTEM INSPECTION FORM
PART A
CERTIFICATION

Property Address: BUCZNLA 200 BAY RD. AMHERST
Date of Inspection: 5/8/98
Address of Owner: (If different)
Name of Inspector: JOHN BLUES

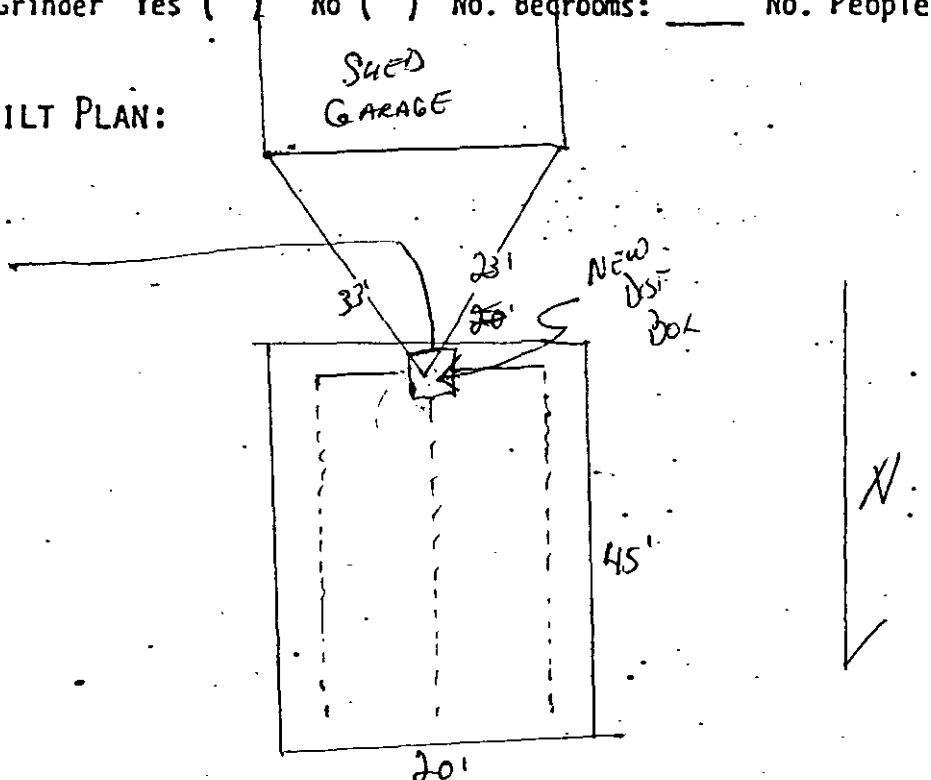
AS - BUILT PLAN:

Description of System: Tank Capacity: EXISTING UNKNOWN

Leach Field ( ) Bed (X) Seepage Pit ( ). Square Feet: 900
