25 CHAPEL ROAD

RE: System Installation Inspection
25 Chapel Street, Amherst

SEPTIC SYSTEM REPAIR PLAN FOR
25 CHAPEL STREET AMHERST, MA

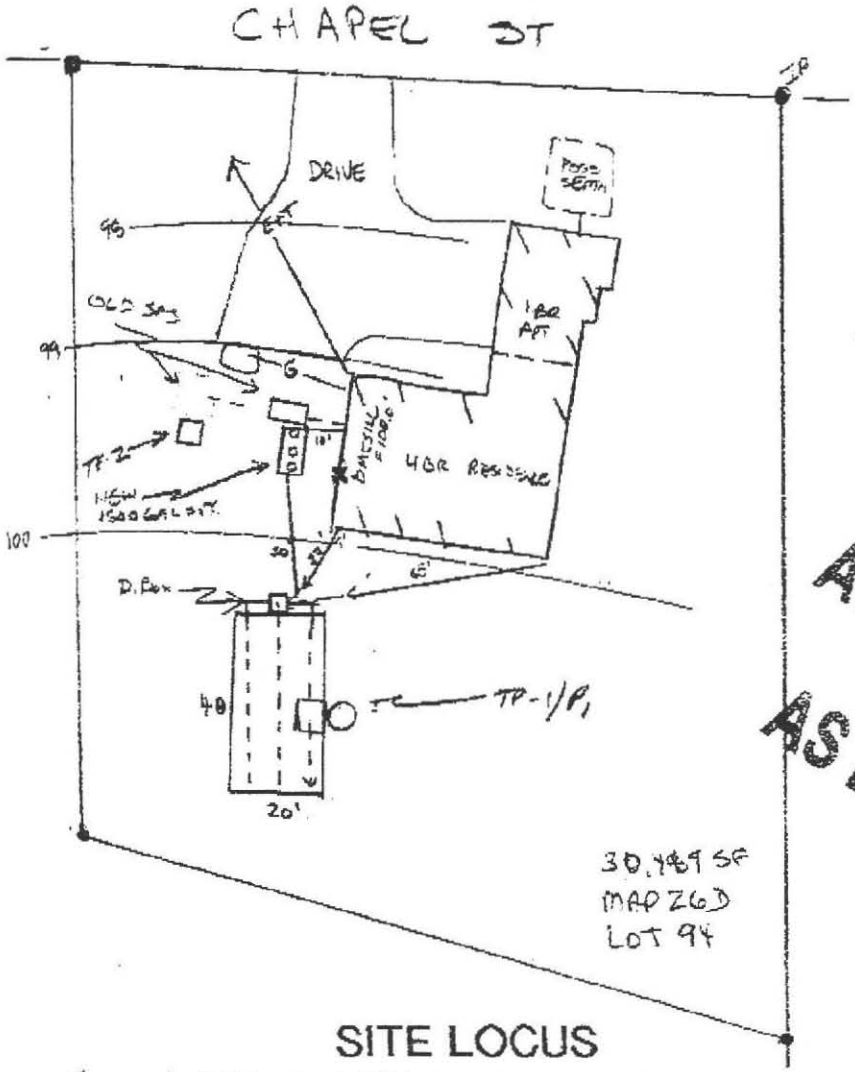
PLOT PLAN

7/18/01

AS BUILT

NO TREES W/IN 10' OF STONE

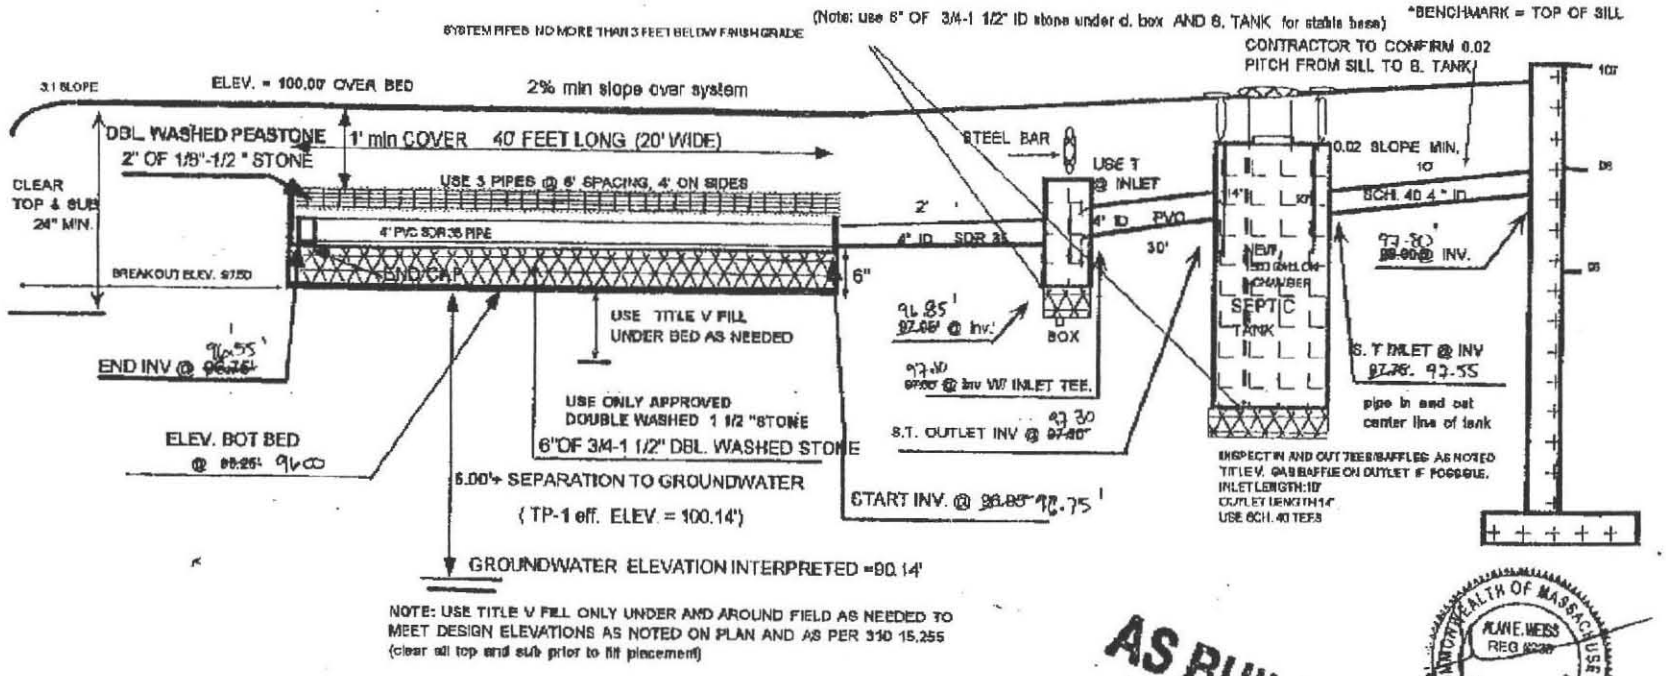
CROSS SECTION OF SEPTIC SYSTEM

AS BUILT

AS BUILT 7/18/01
