30 Flat Hills Rd

Title 5 Official Inspection Form

Subsurface Sewage Disposal System Form - Not for Voluntary Assessments

AMHERST	MA.	01002	OCTOBER 7, 2008
City/Town	State	Zip Code	Date of Inspection

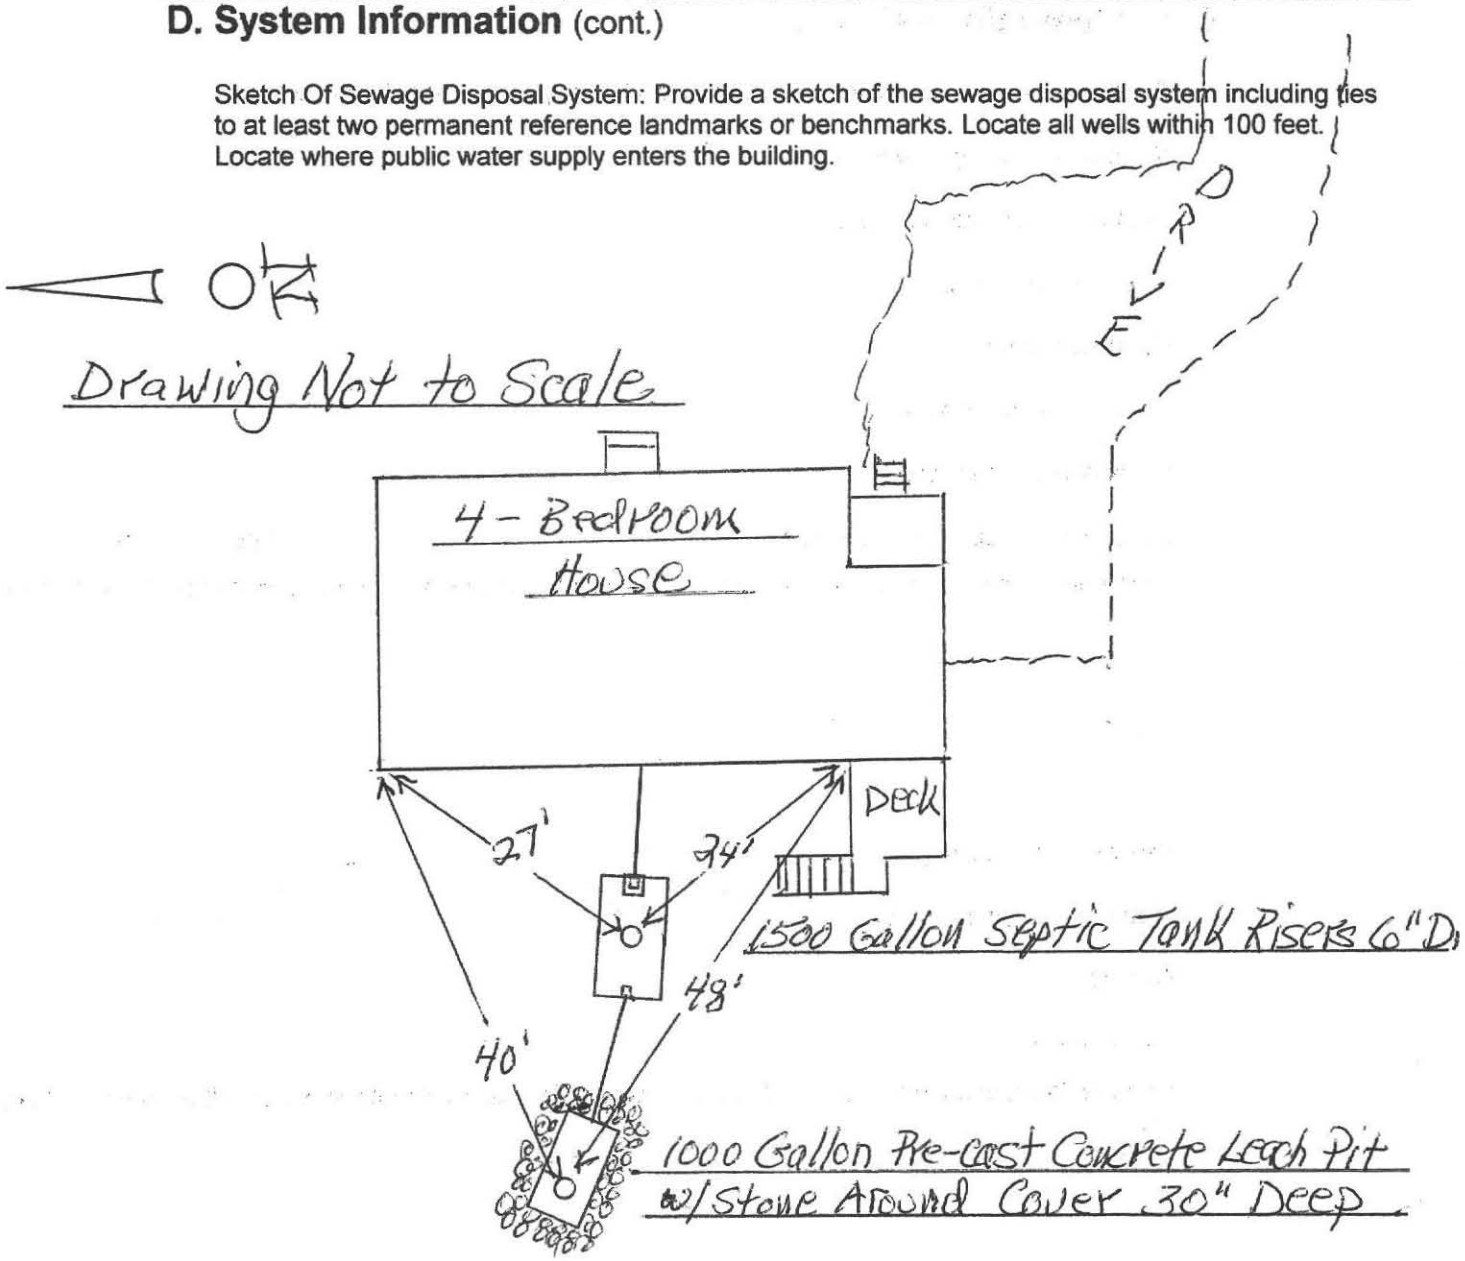
Sketch Of Sewage Disposal System: Provide a sketch of the sewage disposal system including ties to at least two permanent reference landmarks or benchmarks. Locate all wells within 100 feet. Locate where public water supply enters the building.

No Well Within 100' to SAS
