TITLE 5
OFFICIAL INSPECTION FOR - NOT FOR VOLUNTARY ASSESSMENTS
SUBSURFACE SEWAGE DISPOSAL SYSTEM FORM
PART A
CERTIFICATION

Property Address: 300 Harkness Road, Amherst, MA

Date of Inspection: June 7, 2003

SEPTIC REPAIR PLAN FOR MIKE SWITZENBAUM
300 HARKNESS RD., AMHERST

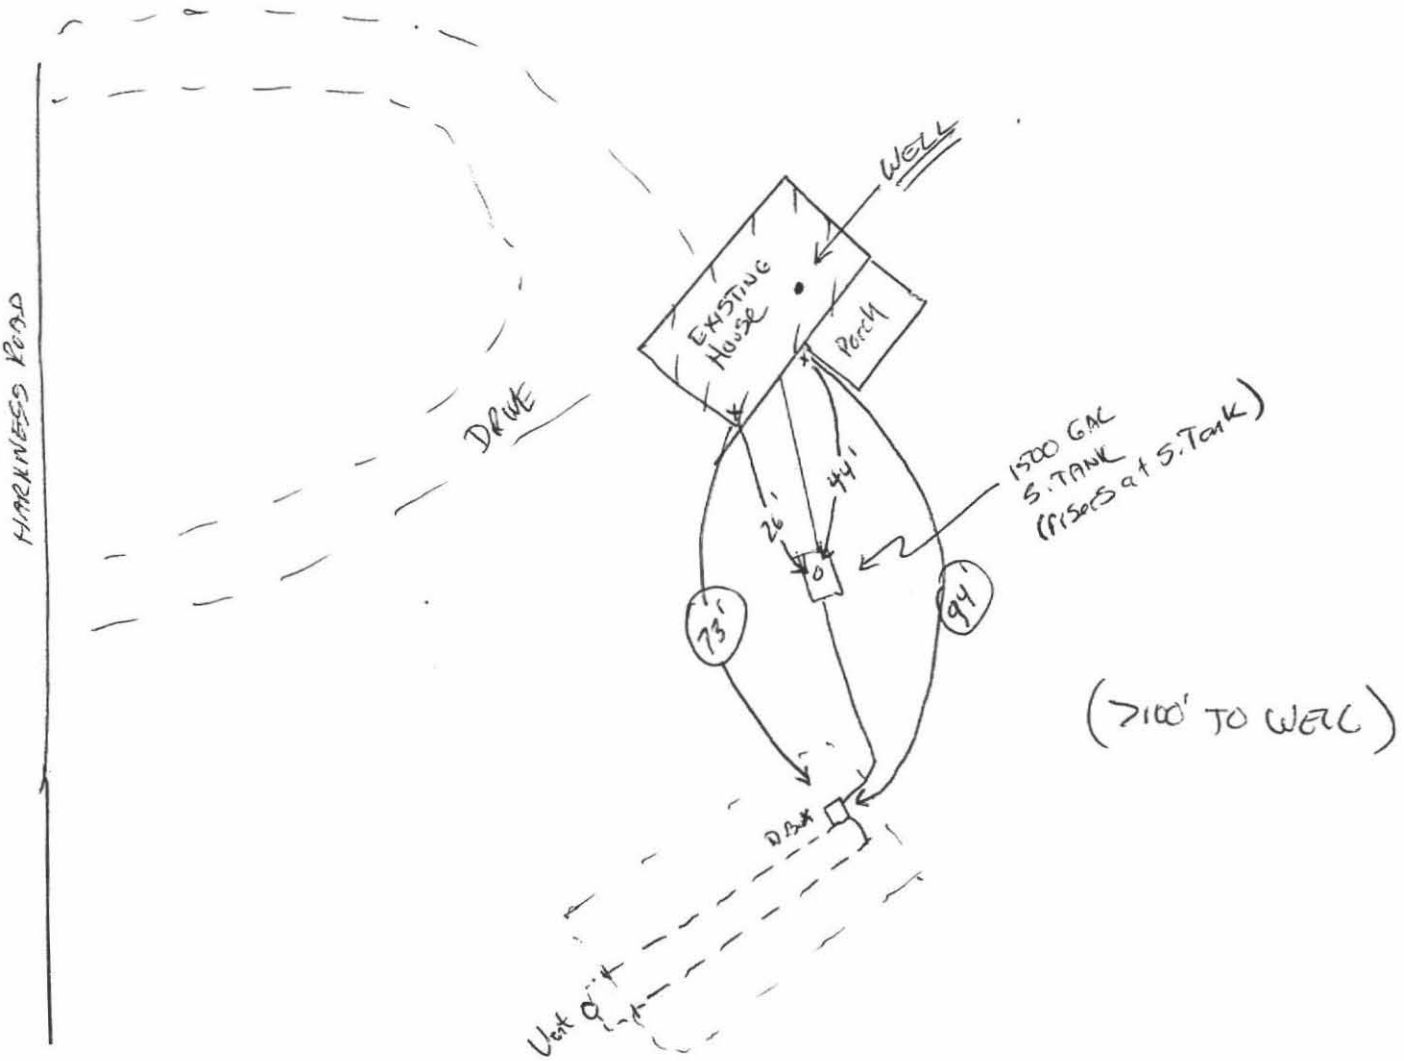
SKETCH OF SEWAGE DISPOSAL SYSTEM

Septic Tank & leaching area was in good condition upon inspection. D Box was found level and functional. S. Tank seam was repaired by Karls. Inspections found, all levels/stains & baffles were ok. We found septic sytem be operational per 1996 plans. System is 6+/- years old.
