TEMPORARY SEWER SERVICE REPAIR

& **Drainage Repair**

Address 122 NORTH PLEASANT ST Inspector PGD ELM

Date of Inspection 4/7/2008 Contractor TOA

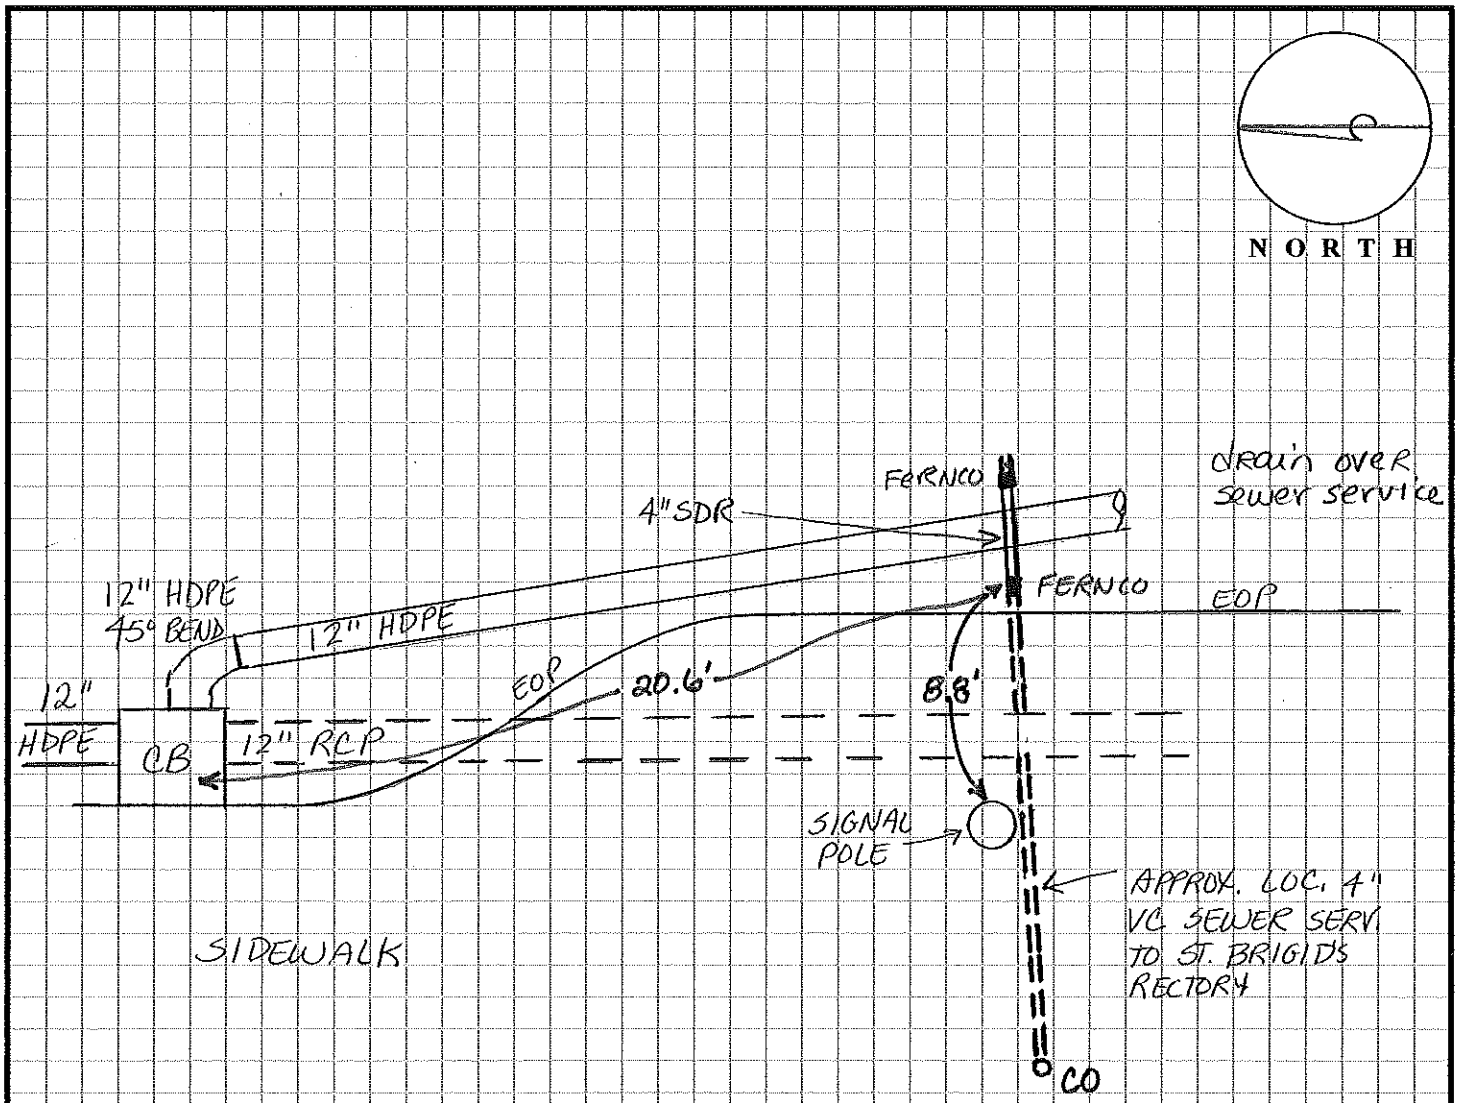
* Town is Rebuilding drain lines. Sewer service broke during construction. Service was blocked anyway. Town flushed service & replaced broken clay pipe with SDR pipe. Used 2 Ferncos. Service will need to be replaced.

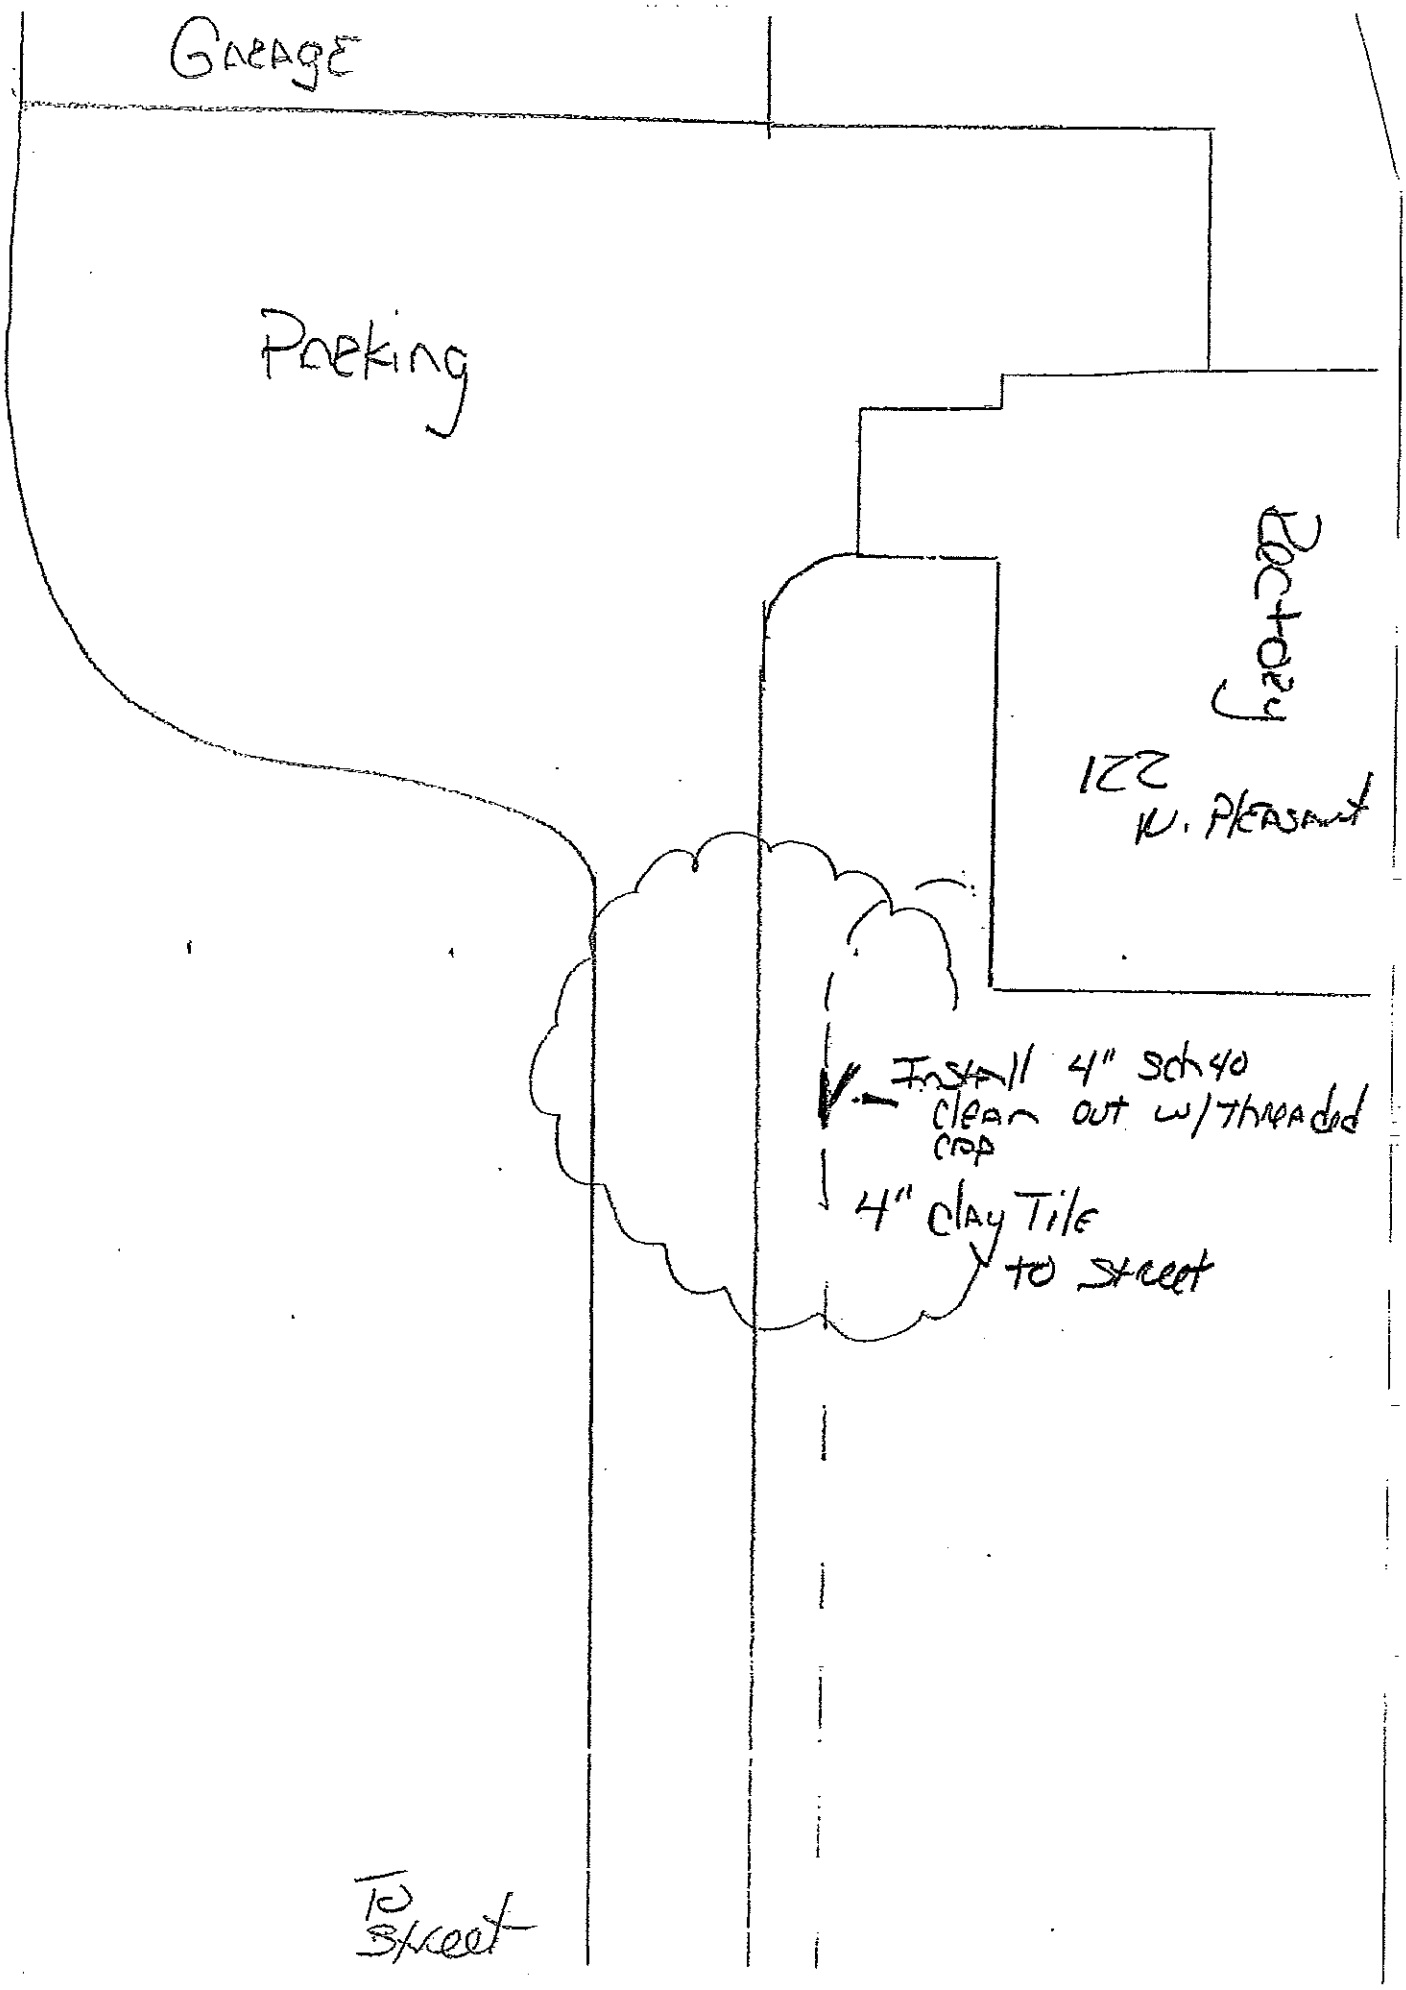
Garage
Parking
Factory
122
W. Pleasant
Install 4" Sch 40
clean out w/threaded
cap
4" Clay Tile
to street
To
Street
