TITLE 5

OFFICIAL INSPECTION FOR - NOT FOR VOLUNTARY ASSESSMENTS SUBSURFACE SEWAGE DISPOSAL SYSTEM FORM PART A

Property Address: 64 Allen Mill Road, Amherst MA

Date of Inspection: June 1, 2006

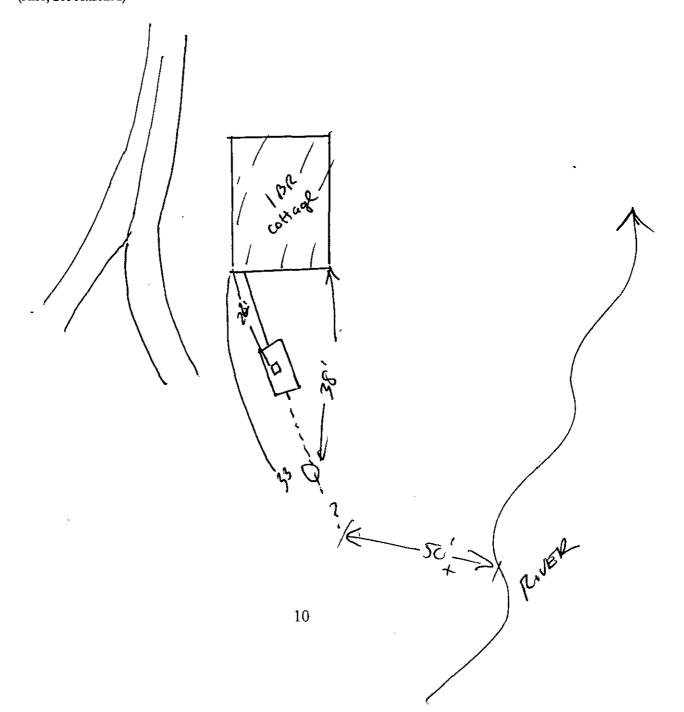
SKETCH OF SEWAGE DISPOSAL SYSTEM

Provide a sketch of the sewage disposal system including ties to at least two permanent reference landmarks or benchmarks. Locate all wells within 100 feet. Locate where public water supply enters the building.
