TITLE 5 OFFICIAL INSPECTION FOR - NOT FOR VOLUNTARY ASSESSMENTS SURSURFACE SEWAGE DISPOSAL SYSTEM FORM

Property Address: 1555 Southeast Street Amherst, MA Owner's Name: Susan TOrrey and Todd Alward

Date of Inspection: June 13, 2005

Name of Inspector: Alan E. Weiss, R.S # 933 Company Name: Cold Spring Environmental Inc.

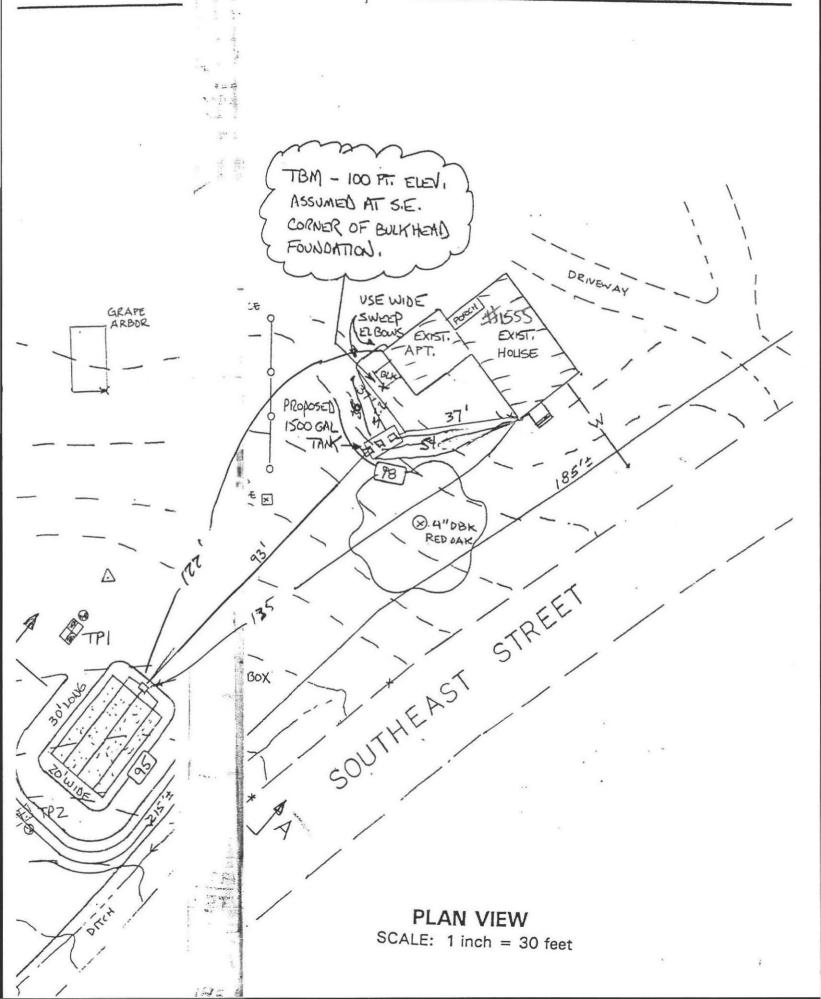
"Attachment A"

SKETCH OF SEWAGE DISPOSAL SYSTEM

Provide a sketch of the sewage disposal system including ties to at least two permanent reference landmarks or benchmarks. Locate all wells within 100 feet. Locate where public water supply enters the building.

See Attached.
